FEDERAL EMERGENCY MANAGEMENT AGENCY

# *Above the Flood:* ELEVATING YOUR FLOODPRONE HOUSE

MITIGATION DIRECTORATE

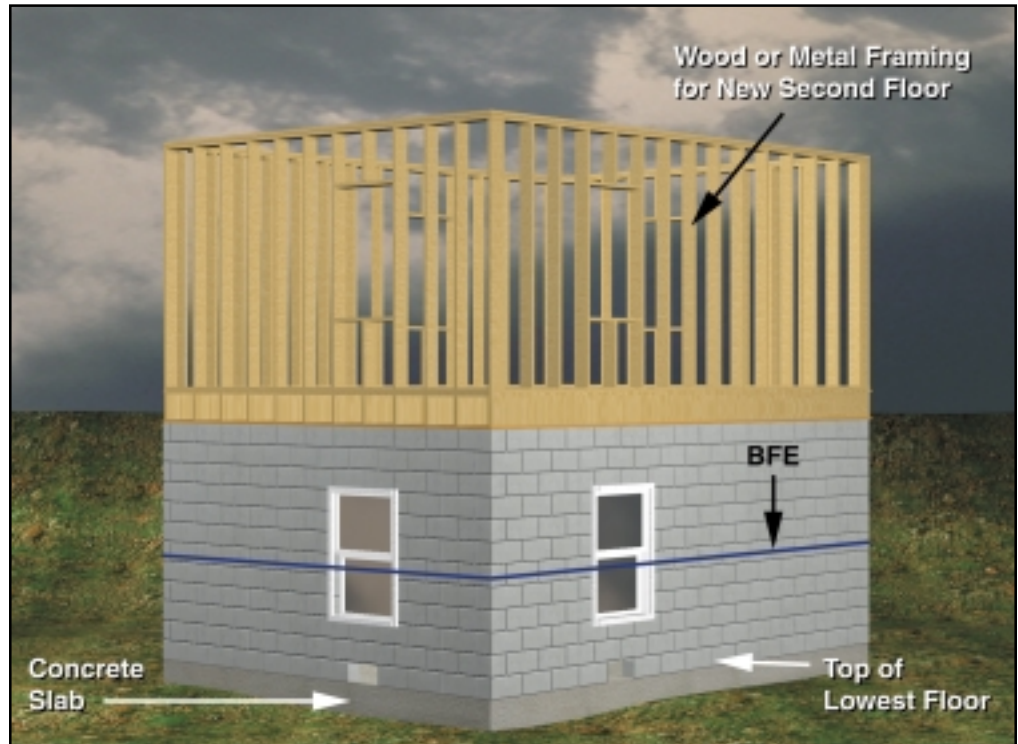
**Figure 15**  
The new second-story floor and walls are built on top of the existing lower story.

As in Technique 1, the repairs begin with the temporary removal of the roof and roof framing (Figure 10). After the roof is removed, construction of the new second story begins. First, a new wood-frame floor is built on top of the existing lower-story walls. The second-story walls are framed with metal or wood studs and set in place on the floor (Figure 15).

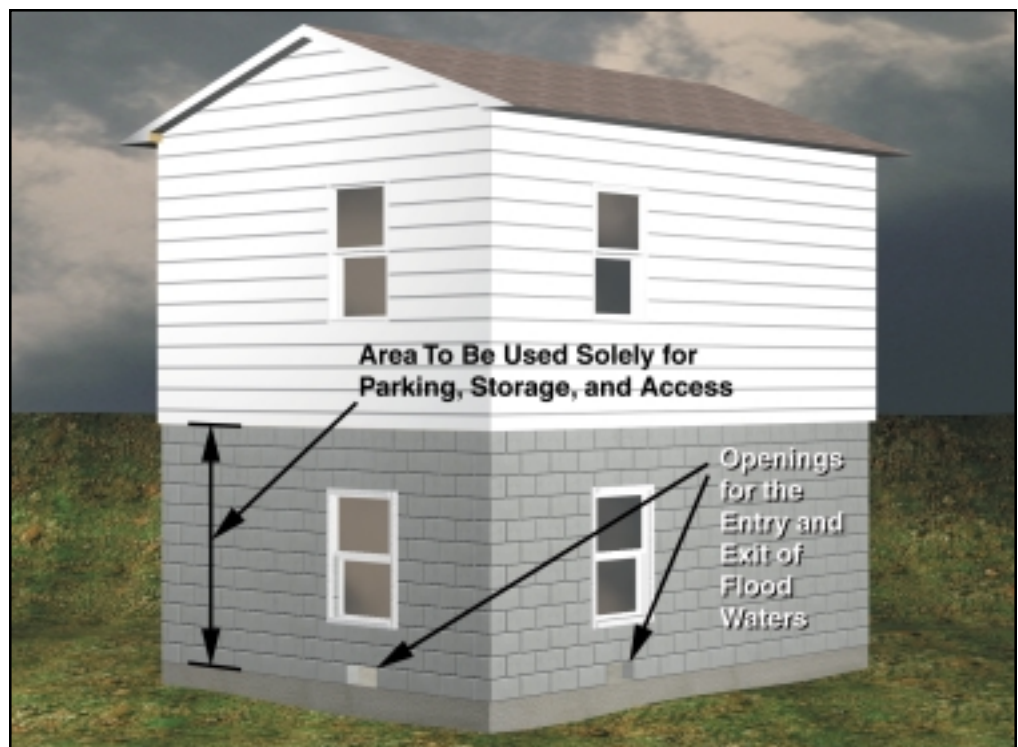
**Figure 16**  
The new second-story walls are covered with siding or stucco.

Some homeowners prefer that the second story be constructed of masonry, but wood- or metal-framing is more common, primarily because it is lighter and less expensive. The roof is replaced, and blocks are removed from the walls to allow flood waters to enter and exit. Exterior sheathing is then added to the framed walls of the second story, the new windows are installed, and siding or stucco is applied to the sheathing (Figure 16).

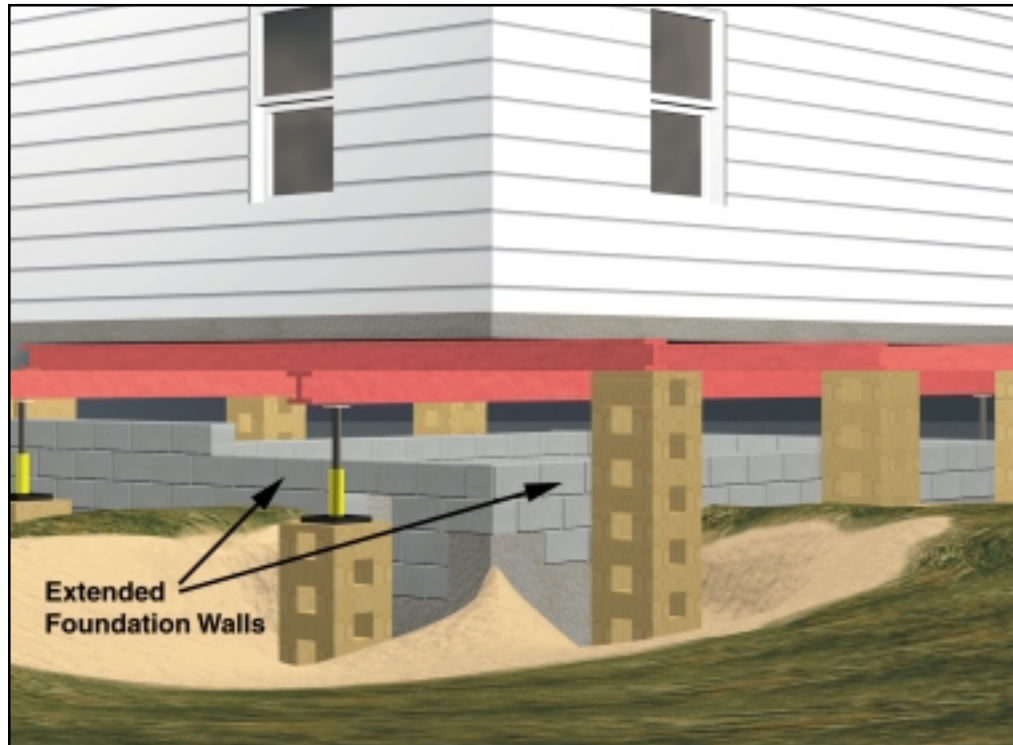
**Figure 20**  
New, extended foundation walls are constructed with concrete blocks.

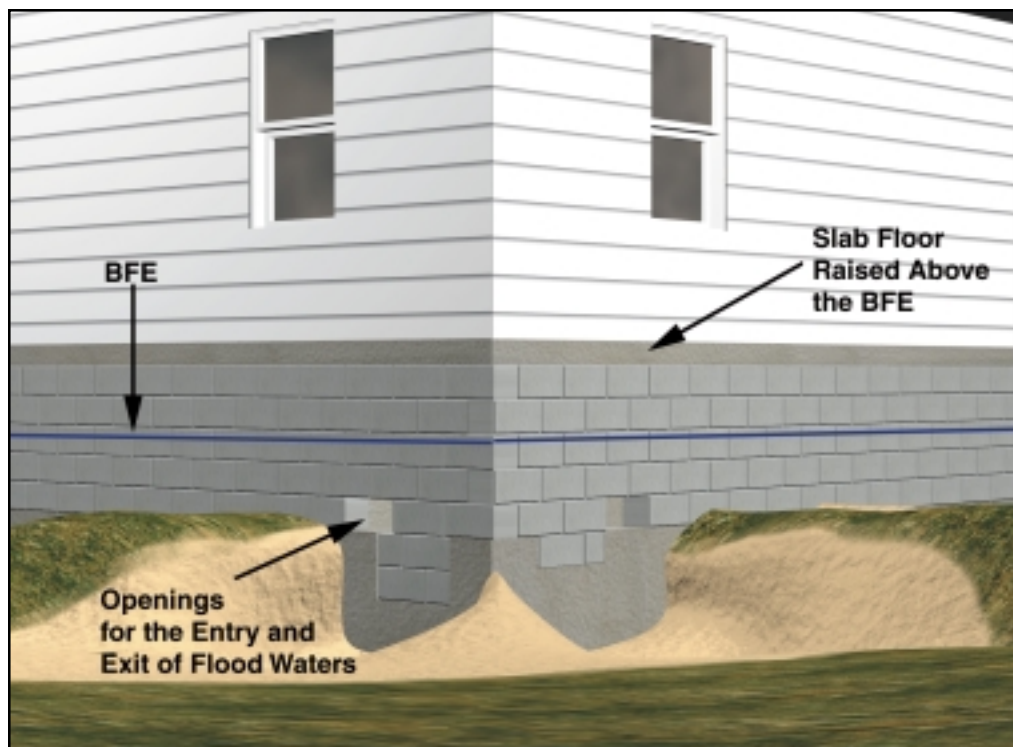
**Figure 21**  
Elevated house and slab on new, extended foundation walls.

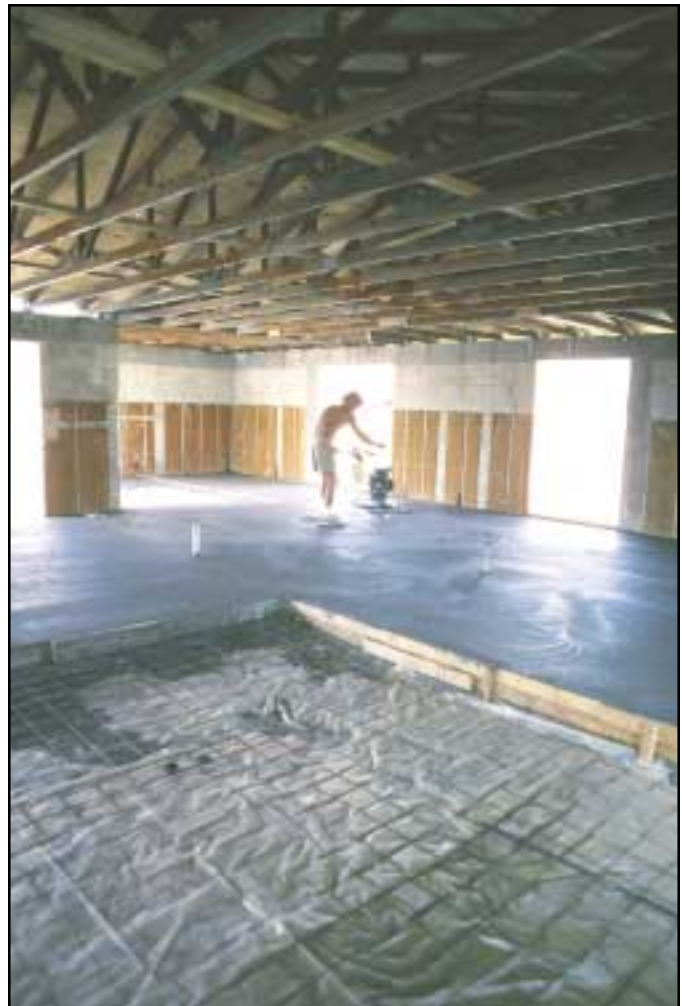
**Figure 26**

The roof has been rebuilt with the salvaged trusses, and most of the new concrete slab has been poured on top of the sand fill. The open area in the foreground, where plastic sheeting and wire reinforcement can be seen on top of the sand fill, is where the remaining part of the slab will be poured.

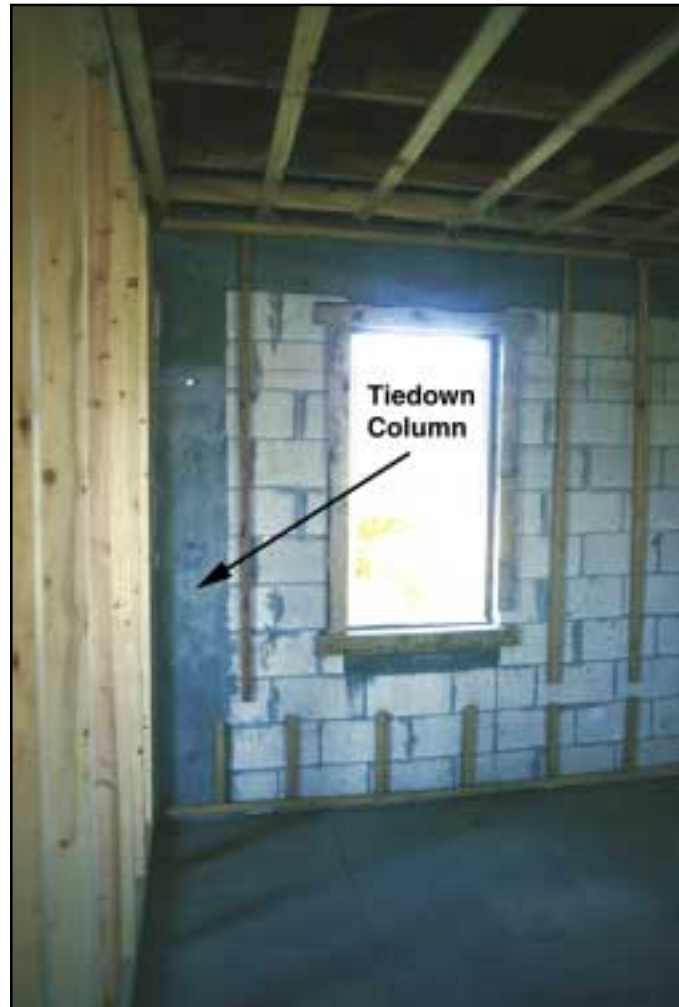
**Figure 46**  
Concrete tiedown columns, such as the one to the left of the window in this photograph, were also used in this house.

**Figure 47**  
The tiedown columns extend down from the new second-story walls and into the original first-floor walls. The columns tie the first and second stories together and provide a continuous load path that helps the house resist the forces of high winds.

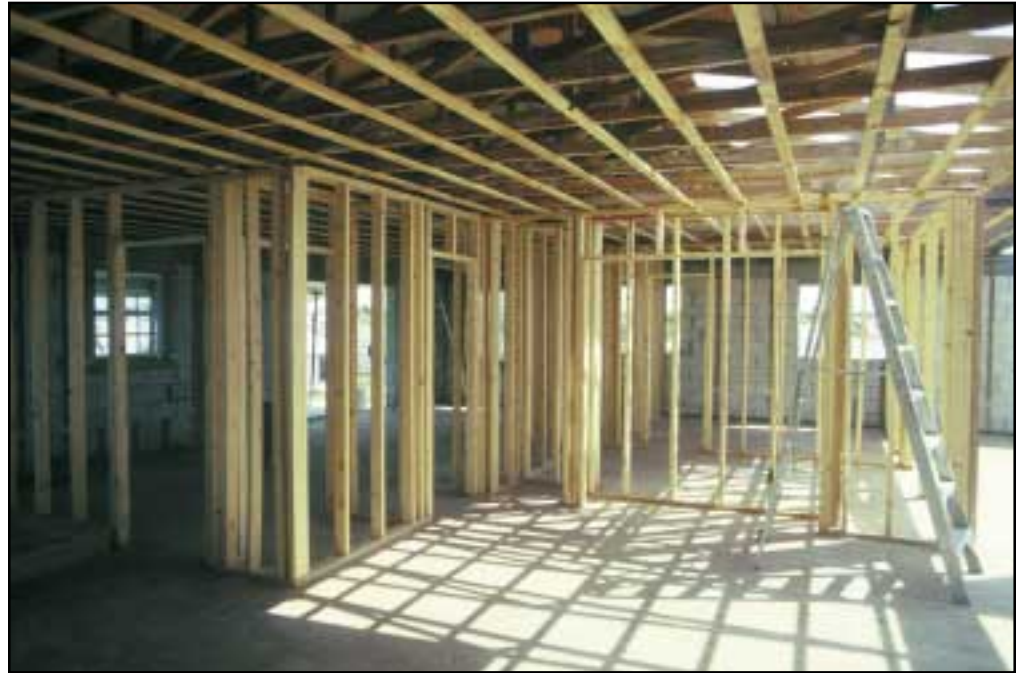
**Figure 48**  
Wood 2 by 4 studs were used to frame the interior walls of the second story.

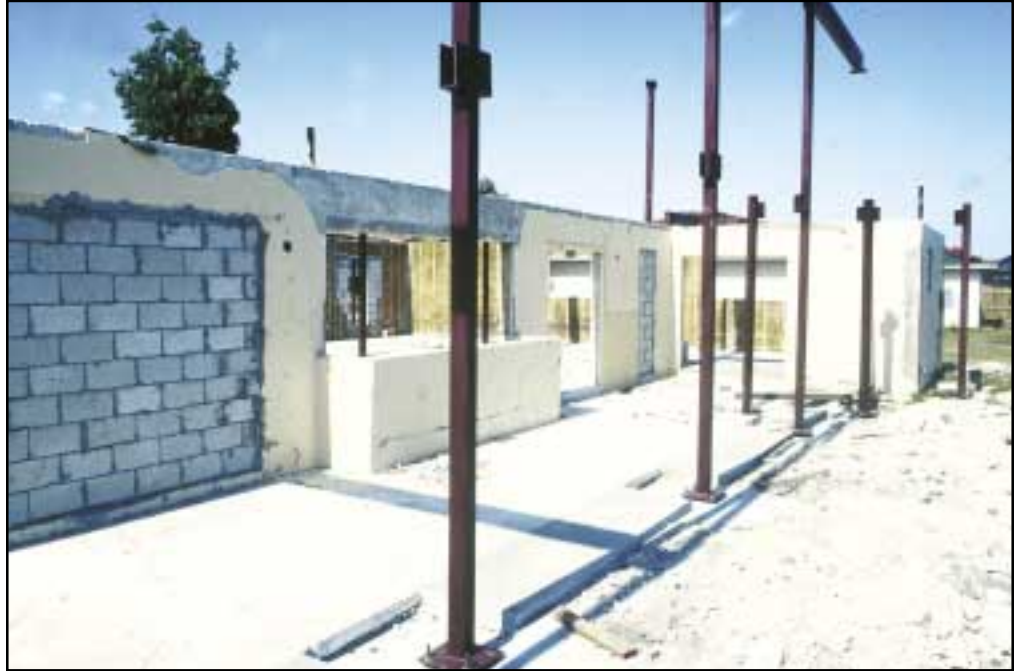
**Figure 52**

The existing first-story walls have been strengthened by the addition of concrete block. Metal columns and beams have been added to help support the new second story.

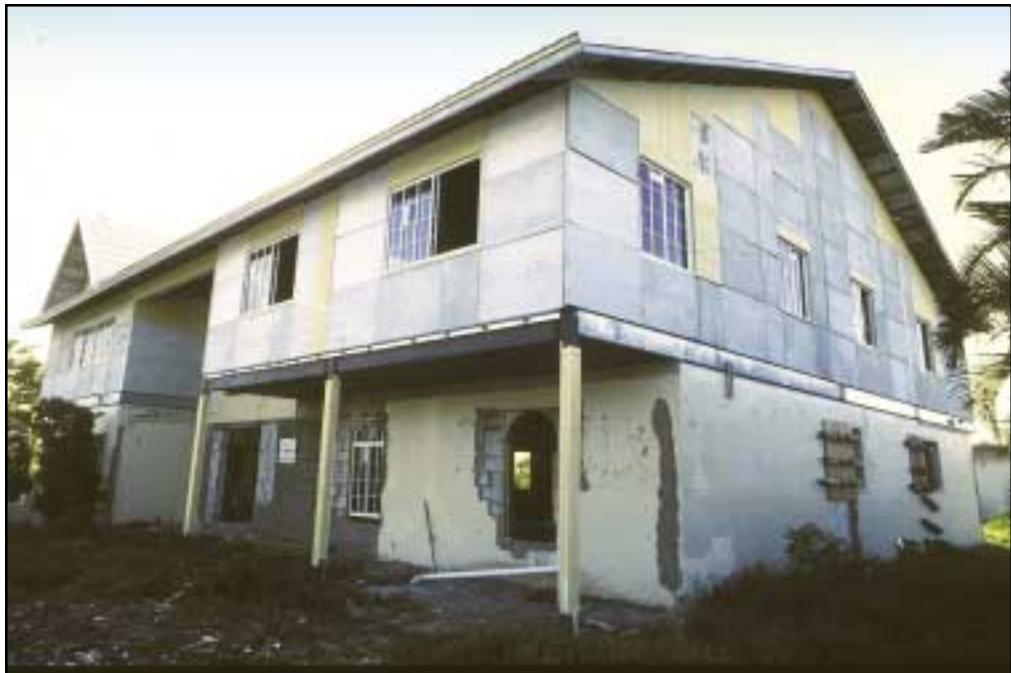
**Figure 59**

The exterior walls  
consist of  
prefabricated  
concrete panels.  
Innovative techniques  
such as those  
employed in this  
project are helping  
homeowners who  
need practical and  
economical methods  
of repairing and  
protecting their  
houses.

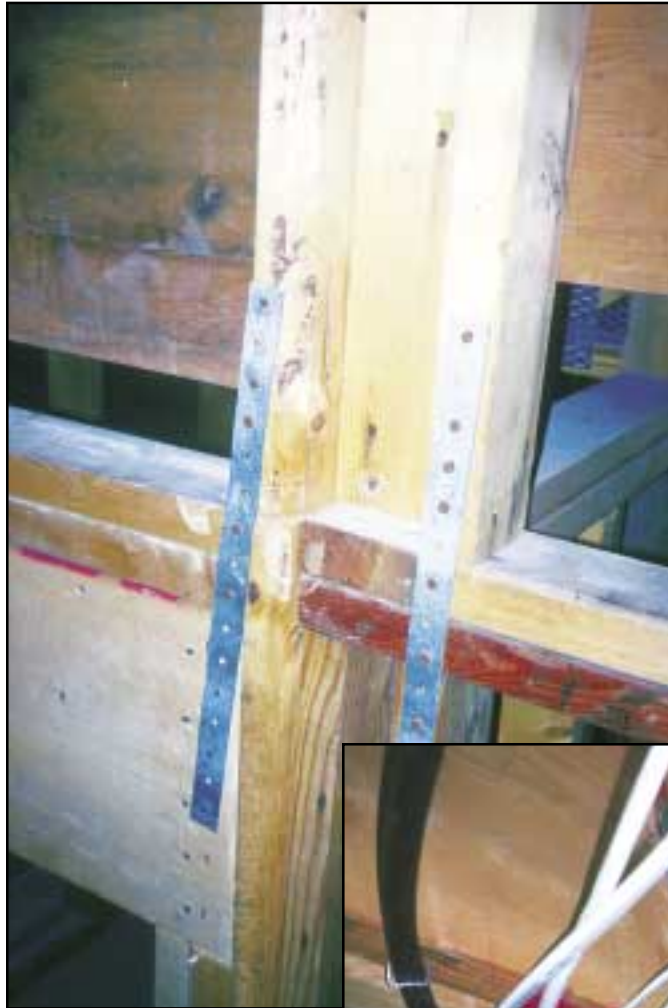
**Figure 70**

Metal hurricane straps are used to tie the structural members together and create a continuous load path from the roof to the foundation.
